ROADSTER
WARRANTY
Bulletin

Campaign no.: 2013-0015
2013-0016

January 23, 2014

Subject: **Spyder™**

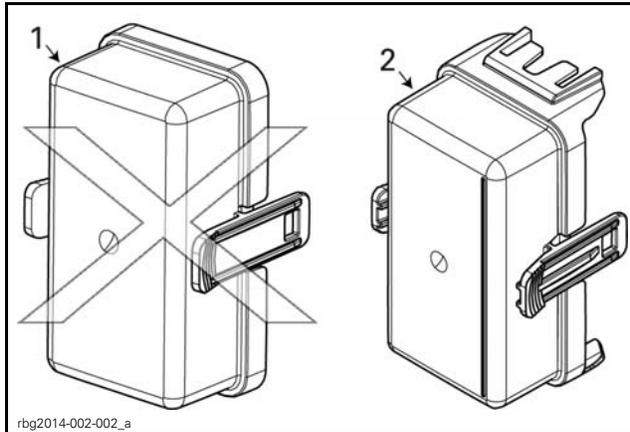
Water may infiltrate either of the front fuse boxes. The source of the infiltration may be:

1. Old fuse box cover
2. New fuse box cover

1. Replace the fuse box covers.
2. Apply liquid tape around base of bus-bar.
3. Apply liquid tape into and around all splices behind fuse boxes.

1. Remove old covers.

2. Transfer fuses to new covers.

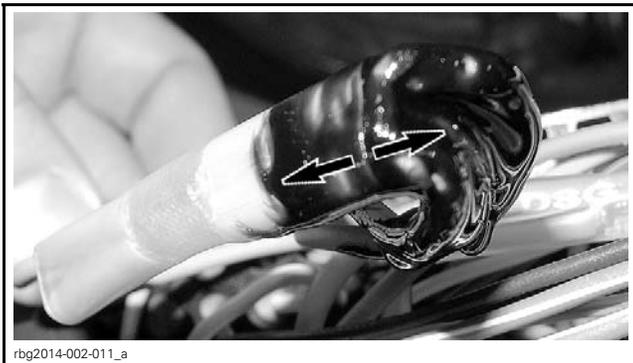
TYPICAL LIQUID TAPE APPLICATION

1. The fuse box cover.
2. The bus-bar connection behind fuse box
3. Any of the wire splices behind fuse box.

5. Seal both ends of all the wire splices with liquid tape.

NOTE: Extend liquid tape onto wires and push the liquid tape into both ends of the splice for a good seal.

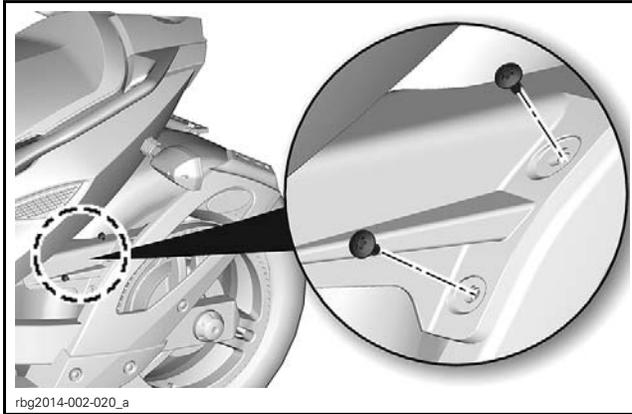
Retaining screws may not secure the belt guard properly.

Remove and discard screws on vehicle and replace with new screws.

TIGHTENING TORQUE	
Upper belt guard retaining screws	5 N•m ± 7 N•m (44 lbf•in ± 62 lbf•in)
